# EVALUATION OF BIOPHOTONIC THERAPY IN A NON-HEALING DIABETIC FOOT ULCER: A CASE REPORT

NIKOLIS, FAUVERGHE *ET AL.*, 2016

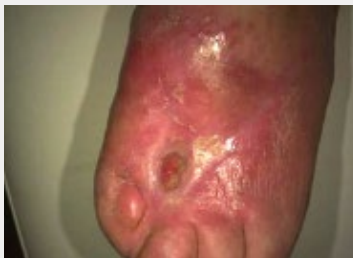
Fig. 1. Initial evaluation

- The patient underwent bi-weekly treatments for 8 weeks, 1 week stop and then further bi-weekly treatments for 14 weeks.
- Wound parameters at the initial evaluation: surface area 1.4 cm<sup>2</sup>; perimeter 44 mm; depth 5 mm (**Fig. 1**).
- At week 12, it showed a 44% reduction in wound size vs baseline (**Fig. 2**).
- Wound parameters at the end of the treatment cycle: surface area 0.3 cm<sup>2</sup>; perimeter 23 mm; depth approx. 1mm, not measurable by the device (**Fig. 3**).
- The wound closed completely in the 2 weeks following cessation of treatments.

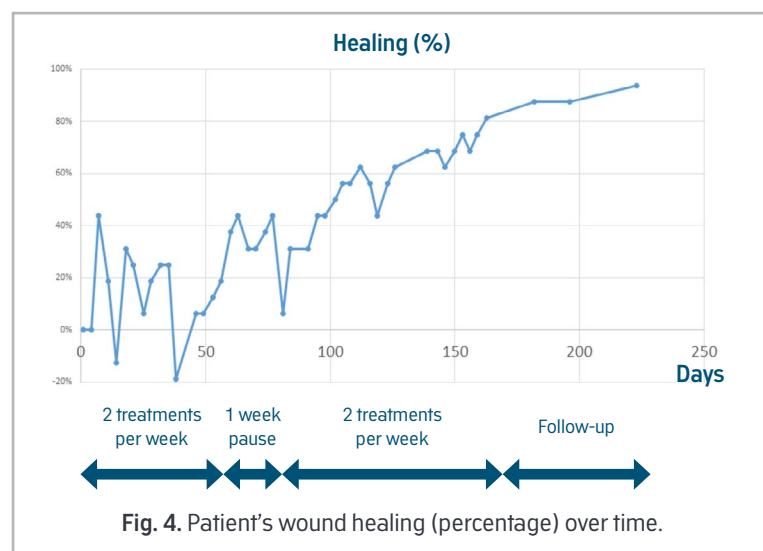
- Evaluation of the wound surface area during the study period demonstrated a major decrease in surface area beginning at week 10 (**Fig. 4**).
